Manhole Inspection Summary

Manhole # S43SS_027MH

Insp Date: **2/22/07 1:04 PM**

Location Address: **1621 GORSUCH AVE**

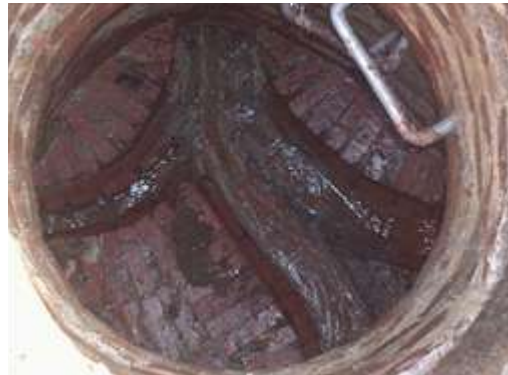
Top View

Corroded steps. Bench debris.

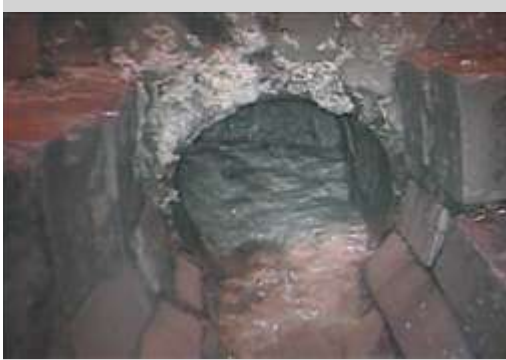
Defect

Barrel infiltration.

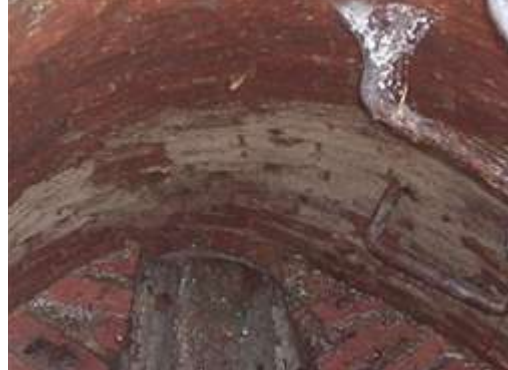
Defect

Frame leaks. Adjustment deterioration, loose brick and infiltration.

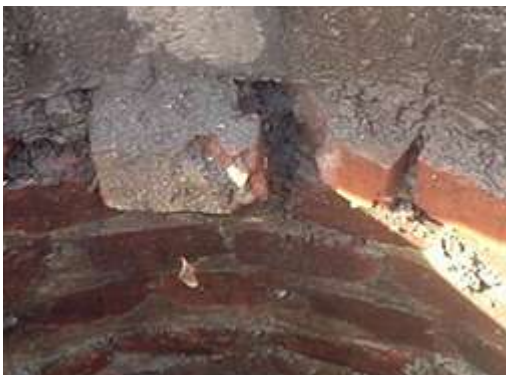
Defect

Frame leaks. Adjustment and Barrel infiltration.

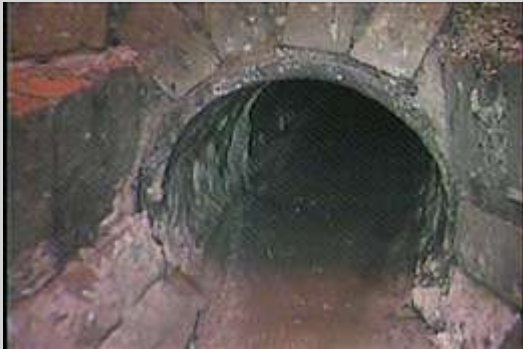
10 in. Circular Gravity Sewer Pipe Out @ 12 O'Clock

Infiltration: **Evidence** Pipe Seal Cond: **Unknown**
